| IDR Sheet | 1 | of | 1 | Sheets | Final Record Book | Page | | | |
| Contract | C-7852 | | | Day | Thursday | | Date | September 8, 2011 | |

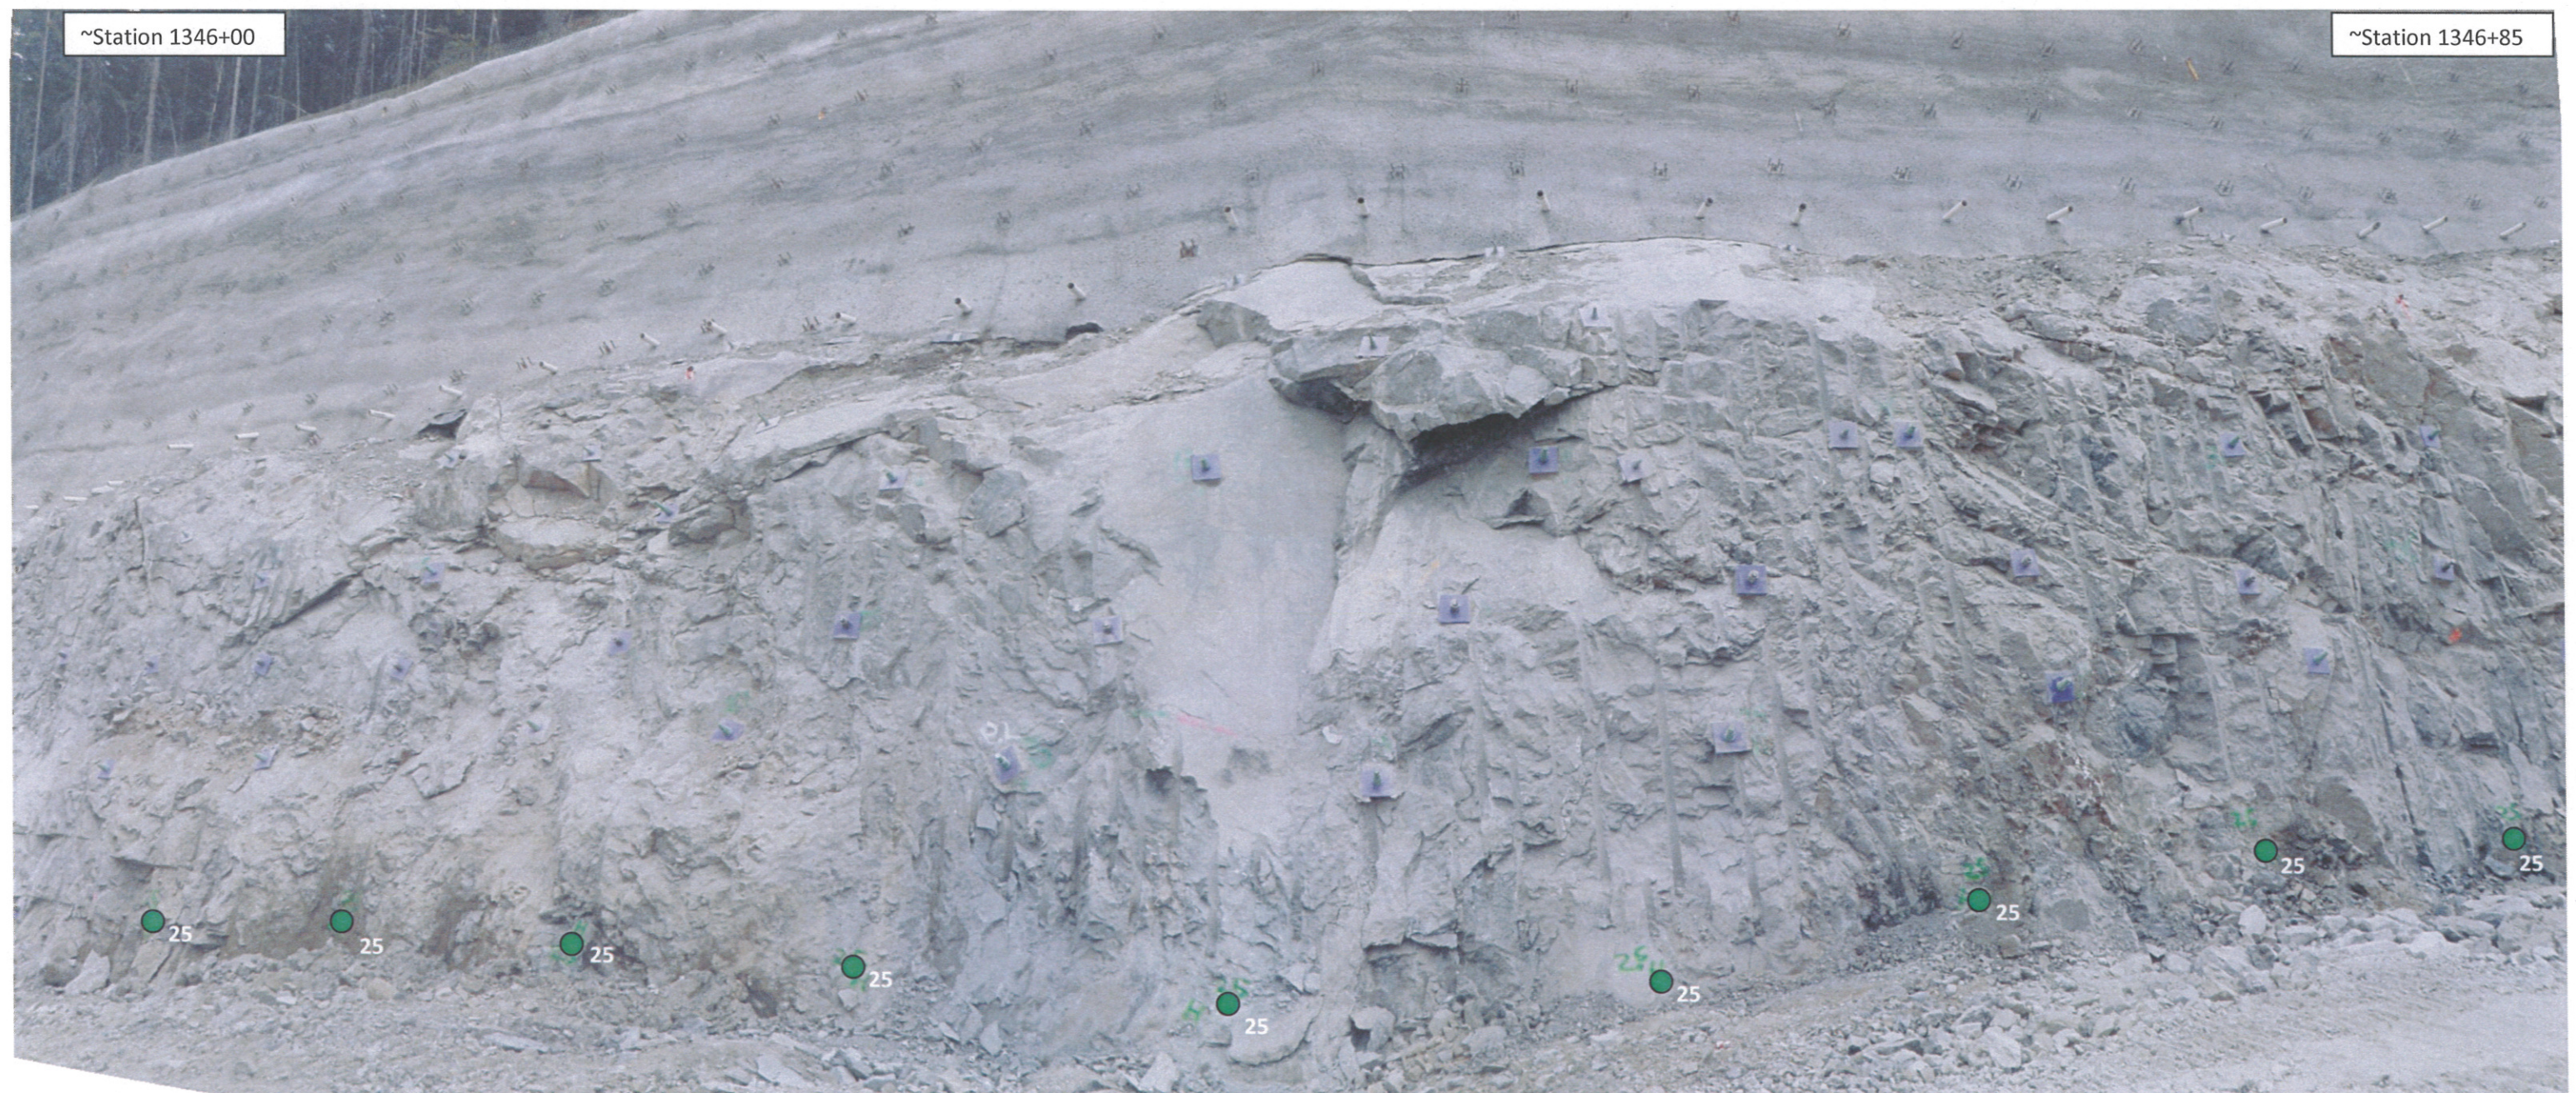
I met Erik on the east end of the project around 12:30 pm and we walked to the soil nail wall to locate the requested prisms. Erik and I found that the two most eastern prisms are located around station 1348+50 so we located three additional prisms between 1348+50 to 1349+00 (Figure 1). I told Erik that these are important and we would like them installed as soon as possible. Erik informed me that there is a blast tonight directly below these additional prisms and they could be installed once the blast pile is mucked down to the current bench elevation which should be done in the morning. Erik and I then located 18 - 25 foot Type H rock dowels at the current bench elevation from approximate station 1346+00 to 1347+75 (Figures 2 and 3). Western States was loading the holes for the upcoming blast beneath the soil nail wall.

Figure 2. A photograph showing the lift inspection from approximate station 1346+00 to 1346+85.

● 25 - Type H Rock Dowels (Minimum Length in Feet)

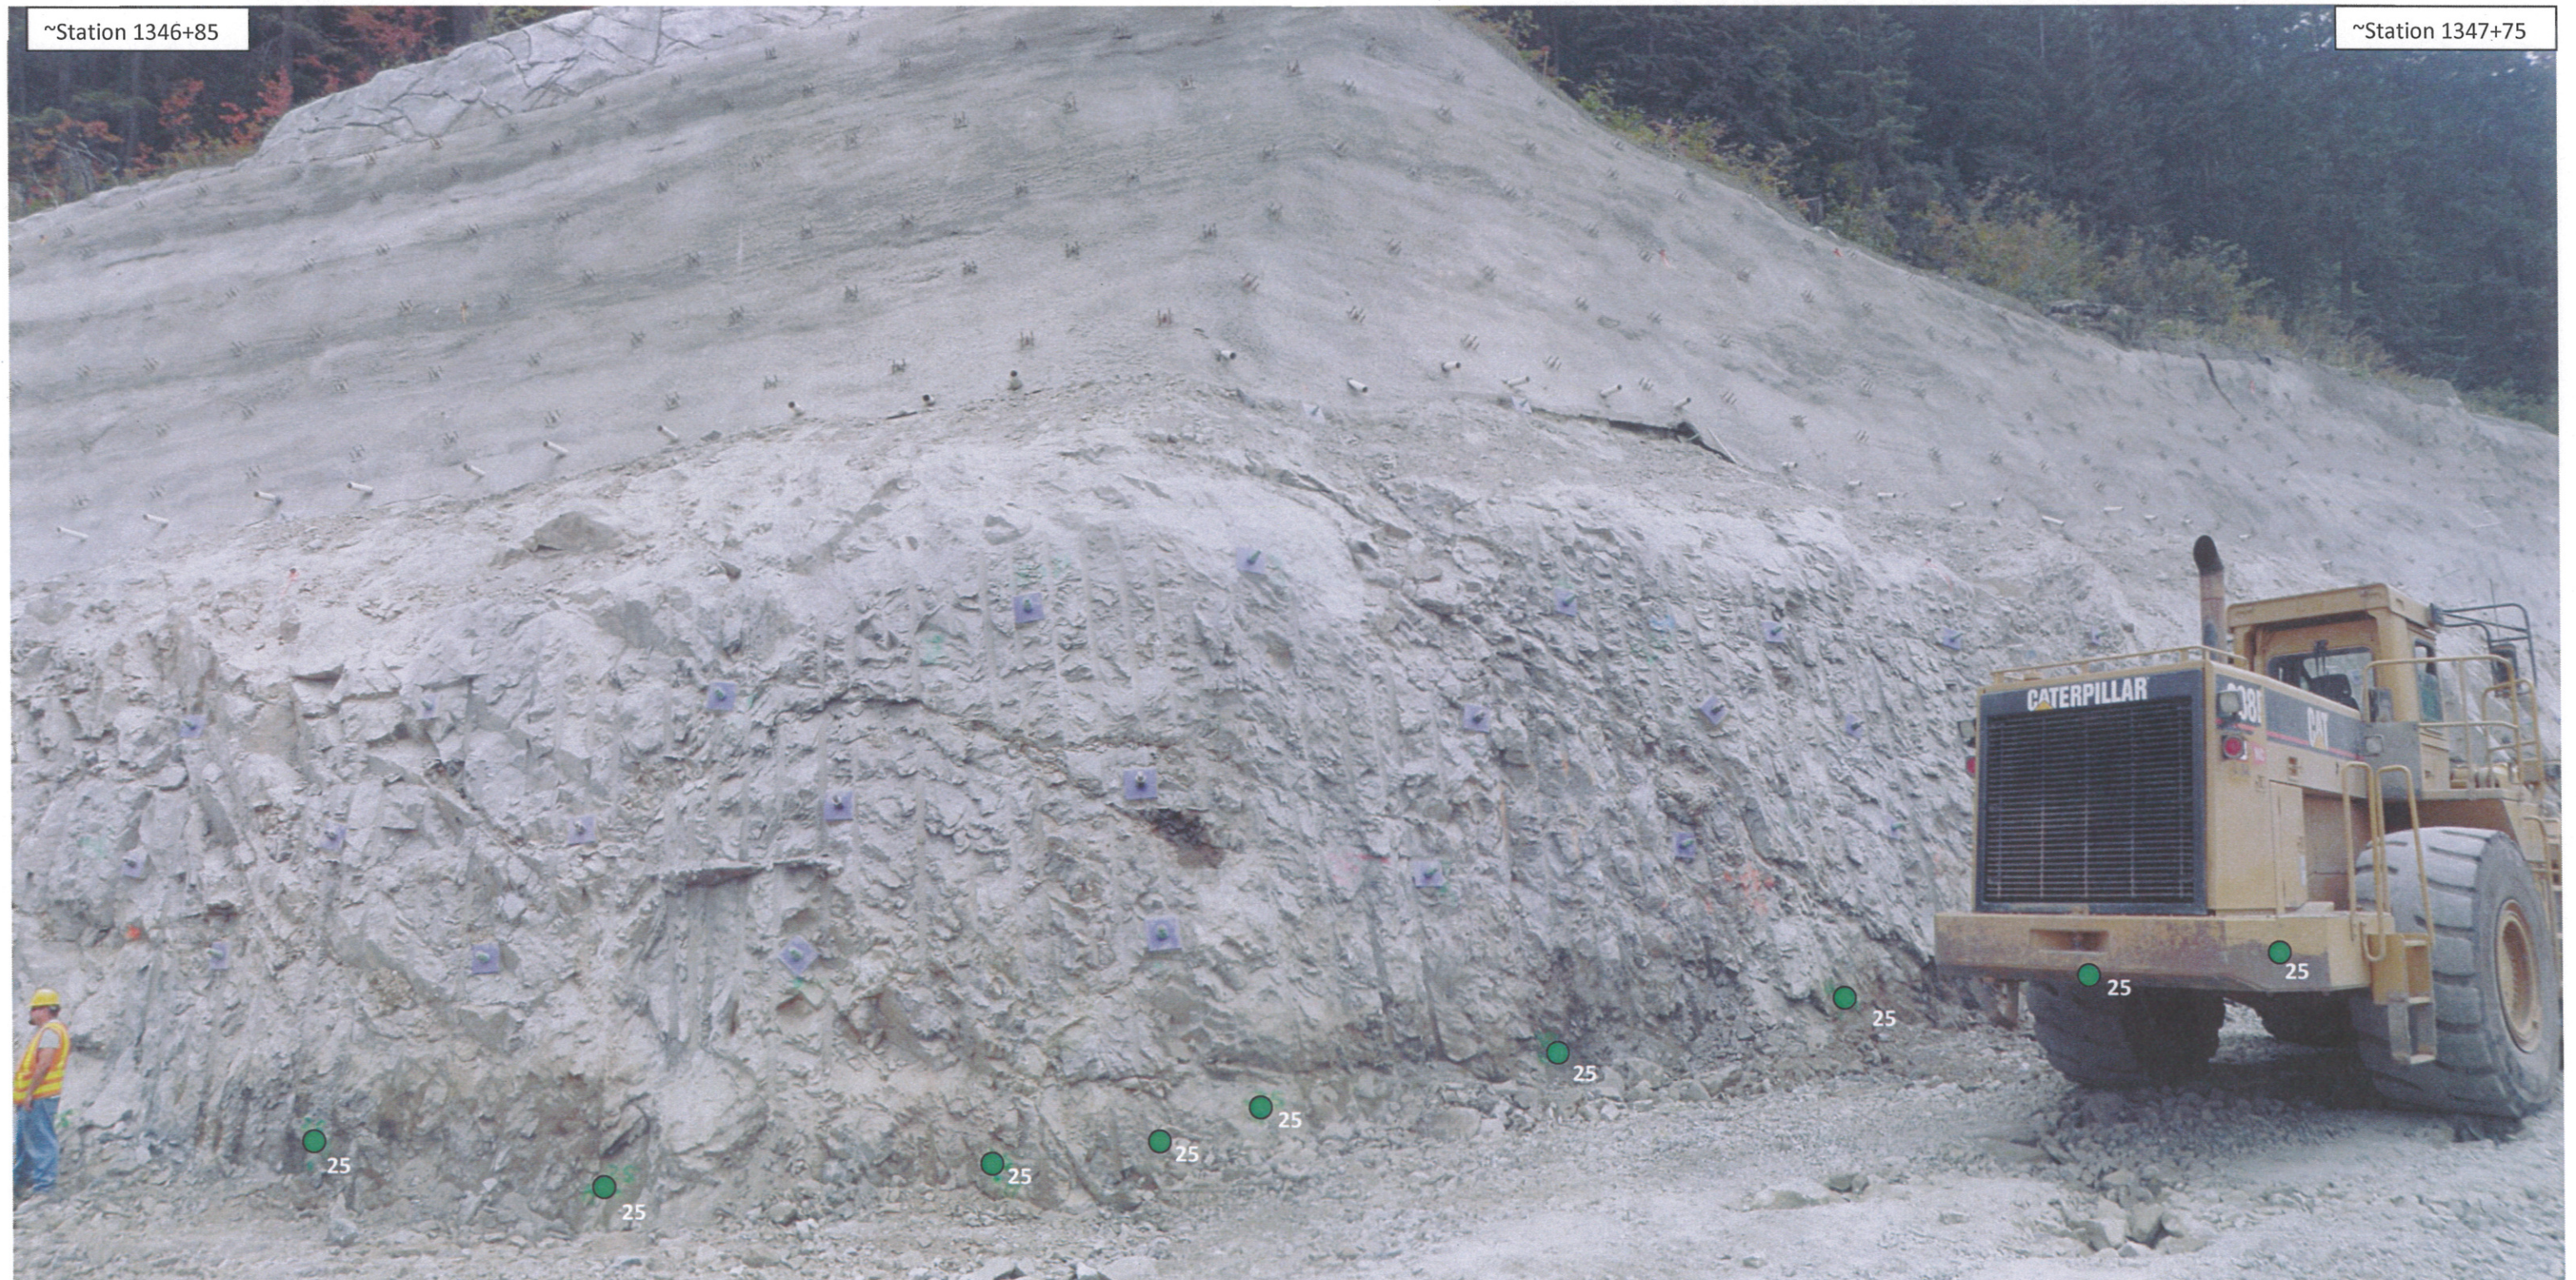
Figure 3. A photograph showing the lift inspection from approximately 1346+85 to 1347+00.

● 25 - Type H Rock Dowels (Minimum Length in Feet)

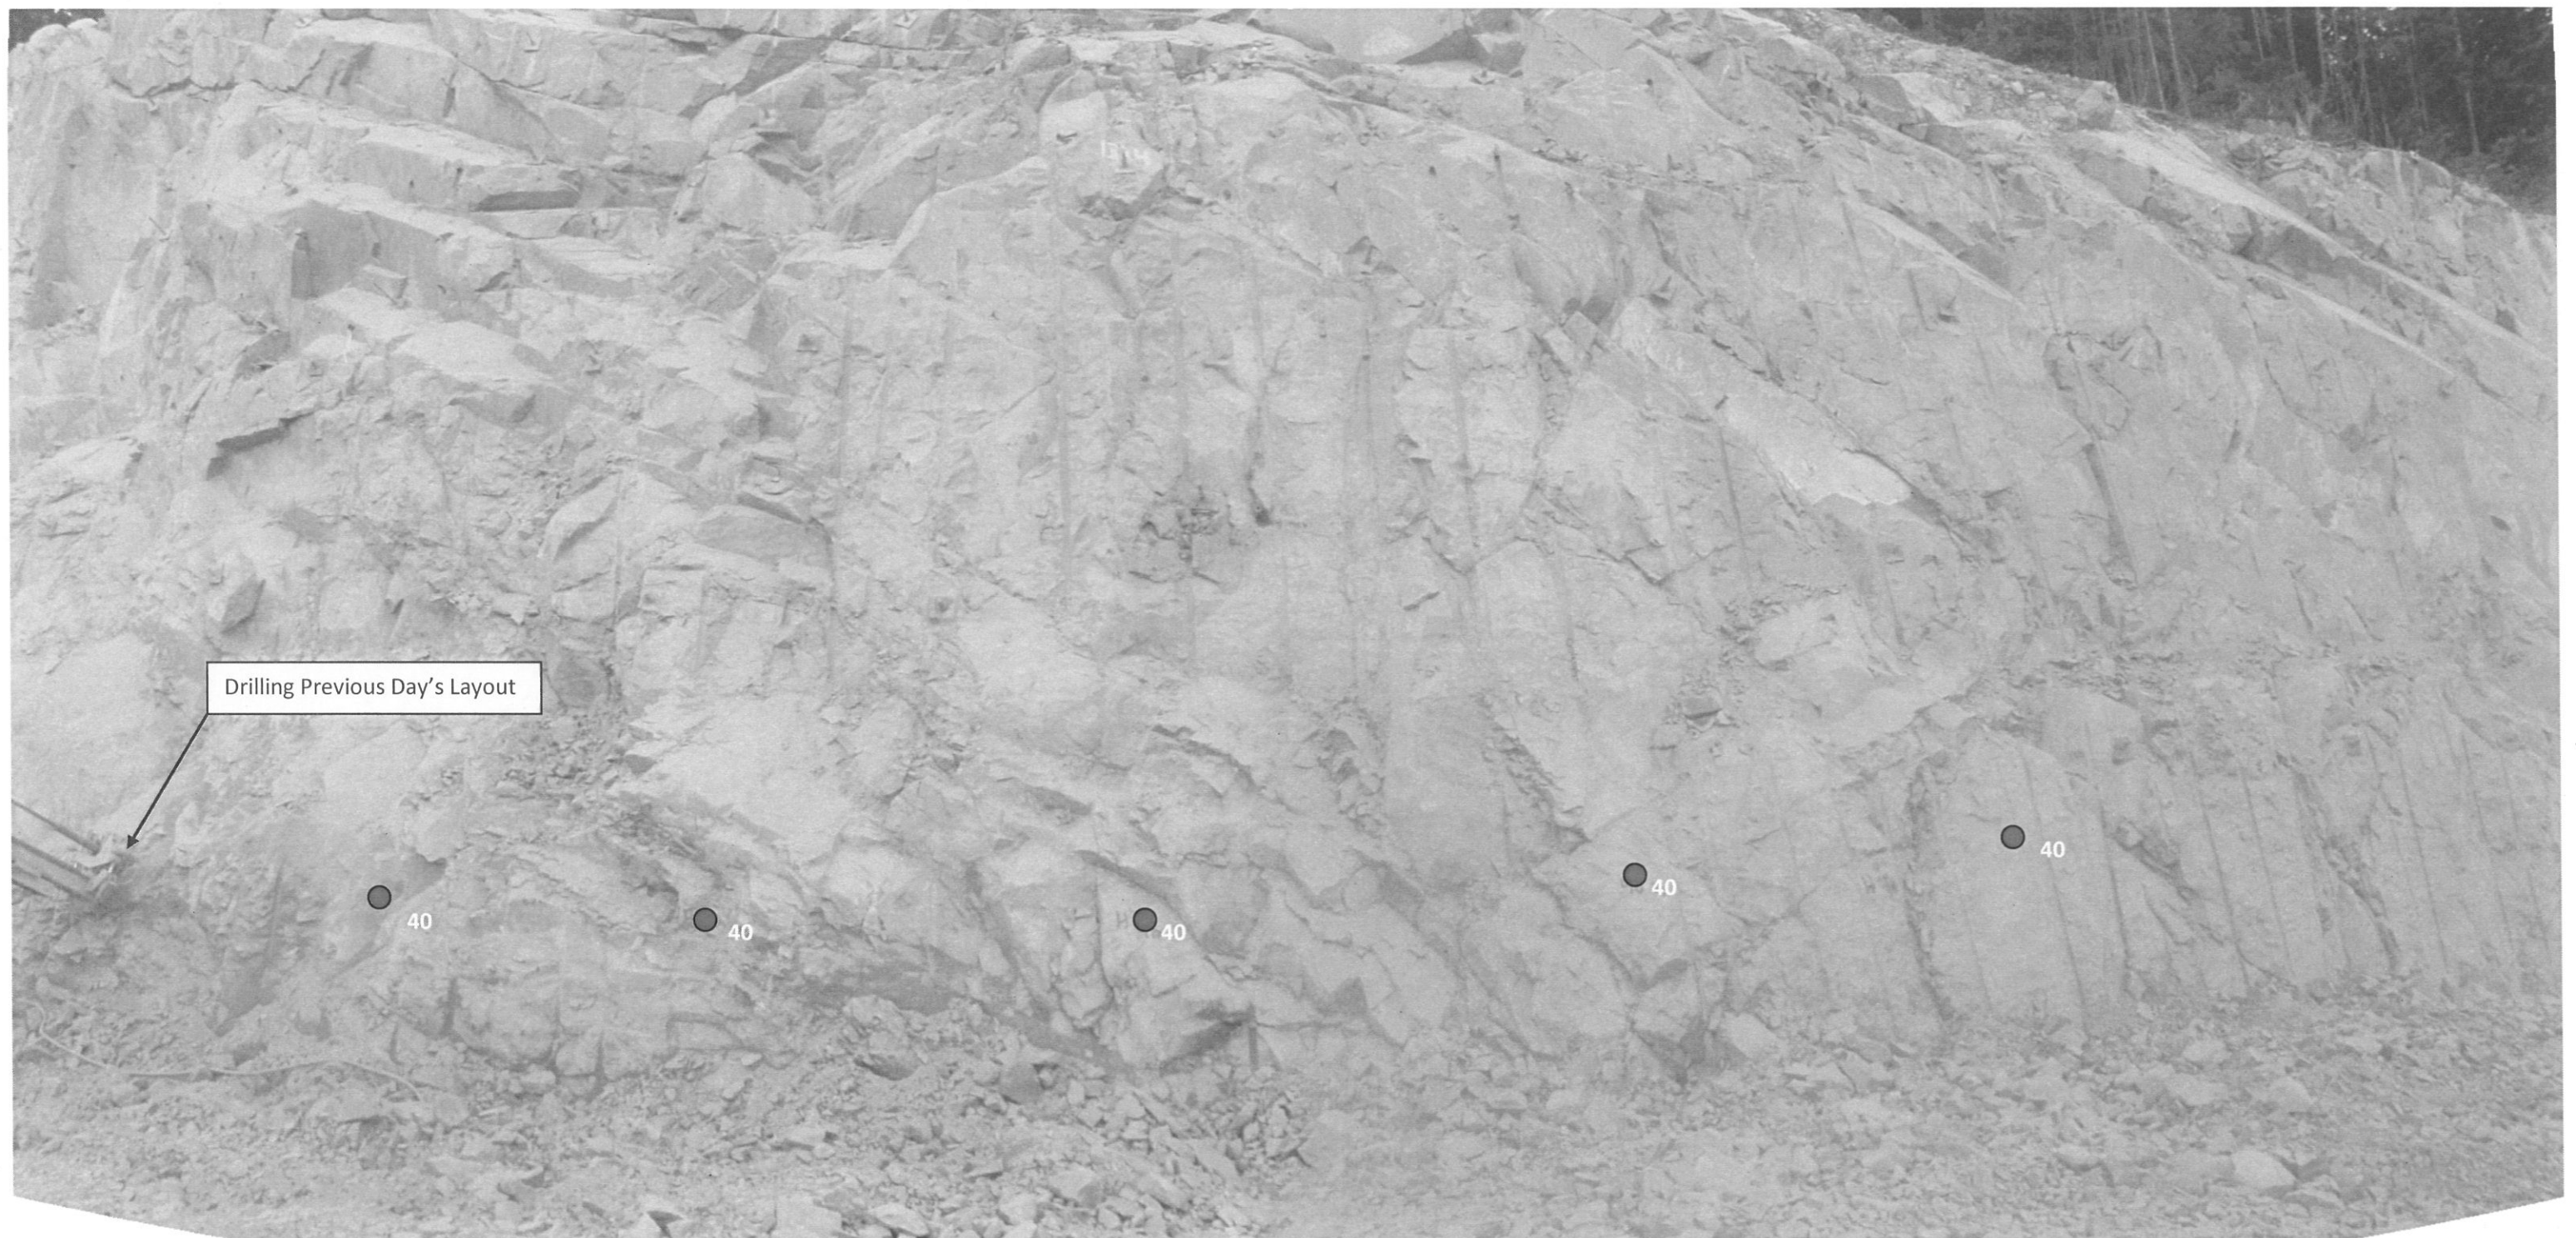
Erik and I then walked up to Jenkin's Knob and continued the layout from yesterday and located an additional 5 - 40 foot Type H rock dowels from approximate station 1333+60 to 1334+25 (Figure 4). While we were on site, NW Cascade was drilling the rock dowels we laid out yesterday. Erik and I inspected the pre-split lines for this section and many of them drift in and out of the slope and are not straight horizontally or not drilled on consistent 24" spacing as we have seen in other areas of the project (Figures 5 and 6).

Figure 4. A photograph showing the lift inspection from approximate station 1333+60 to 1334+25.

● 40 - Type H Rock Dowels (Minimum Length in Feet)

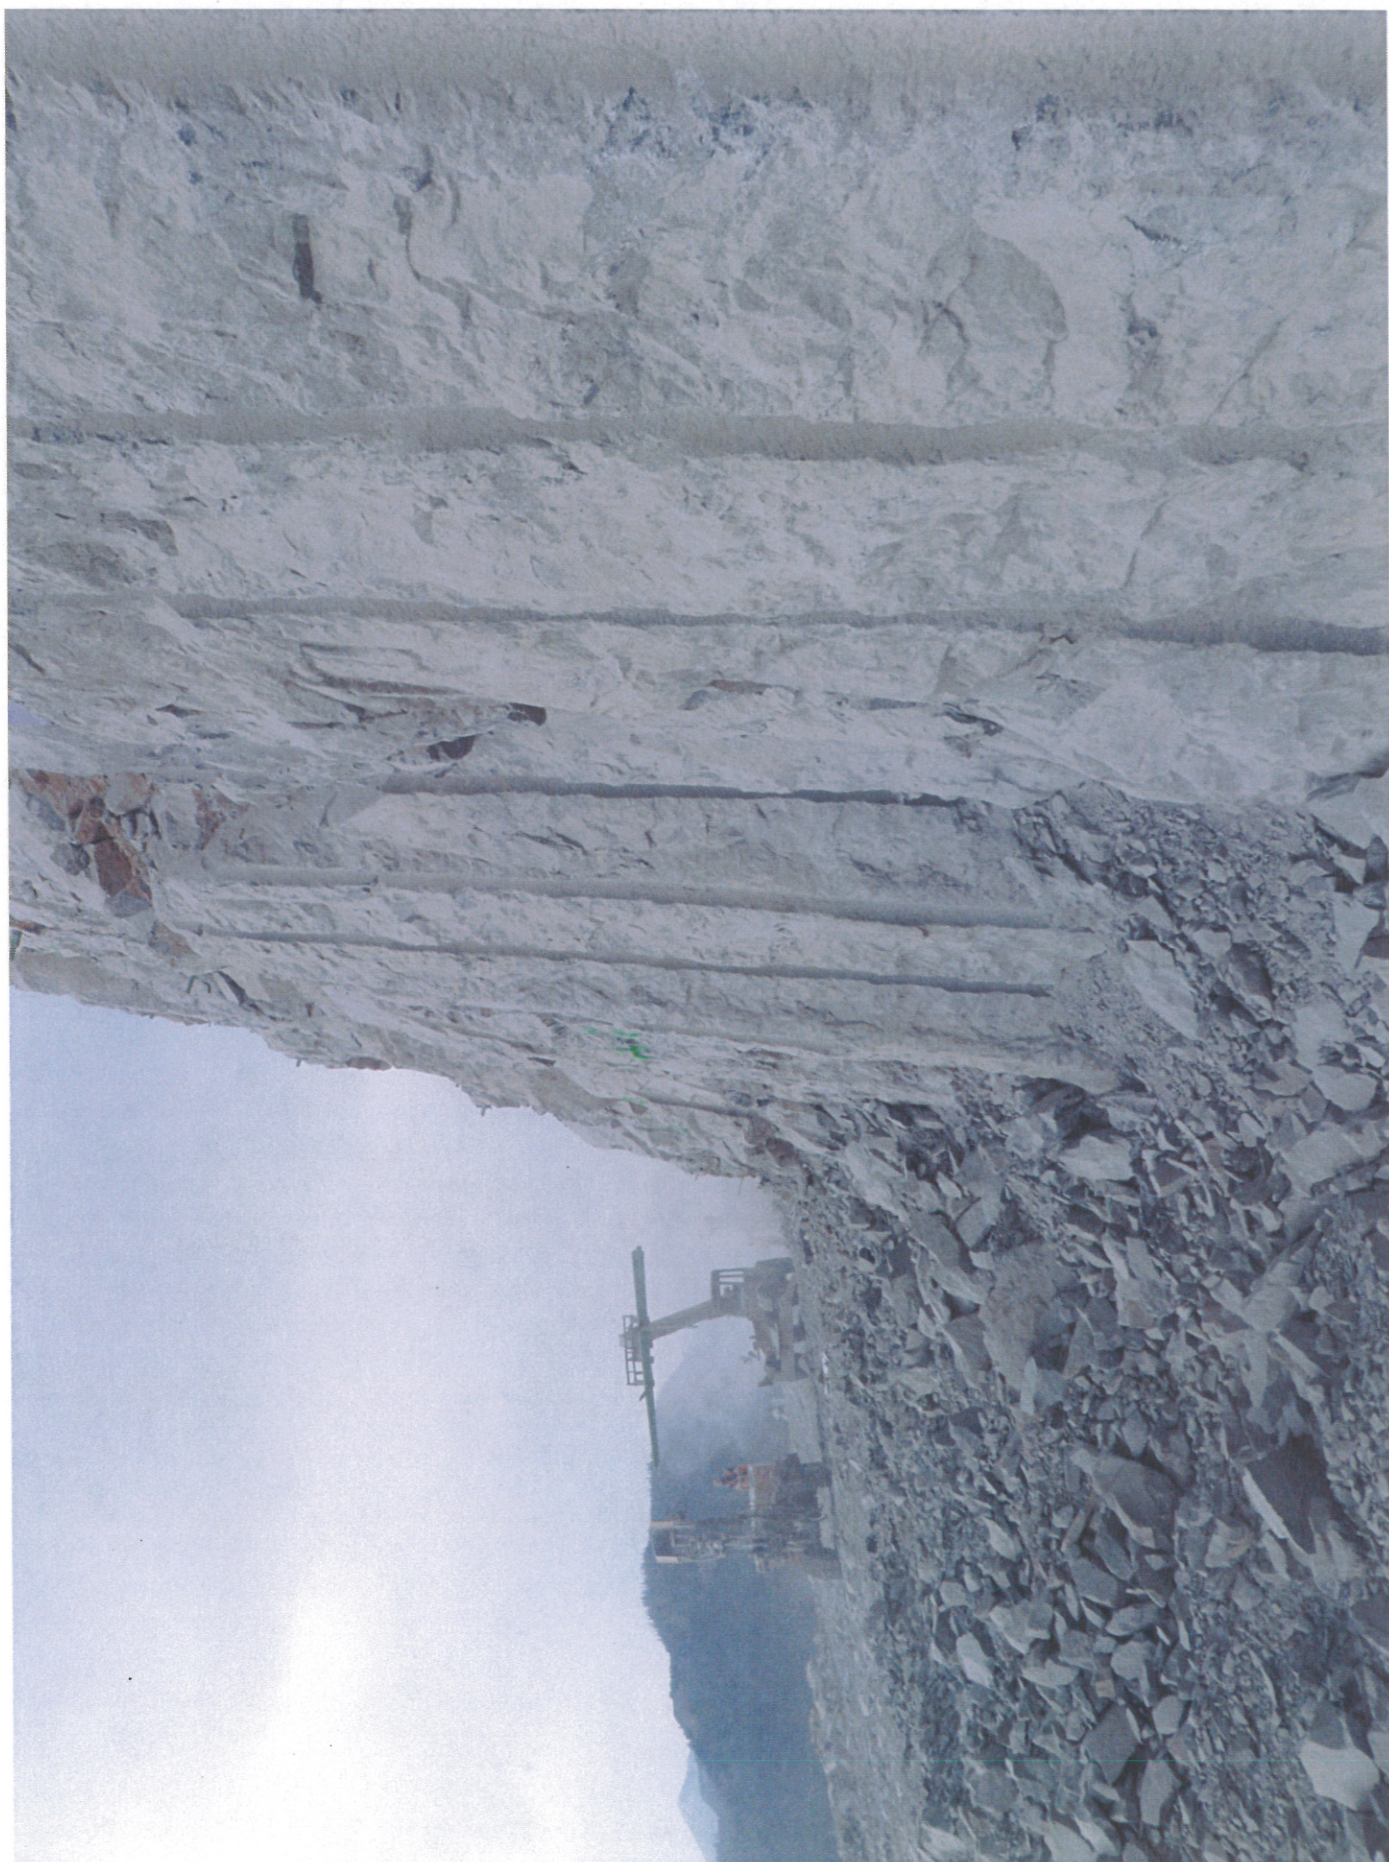
Figure 5. A photograph showing the irregular pre-split lines. Notice how the drill holes go in and out of the slope.
